## STORRS POND DAM

NH 00050

### PHASE I INSPECTION REPORT NATIONAL DAM INSPECTION PROGRAM

NOVEMBER 1979

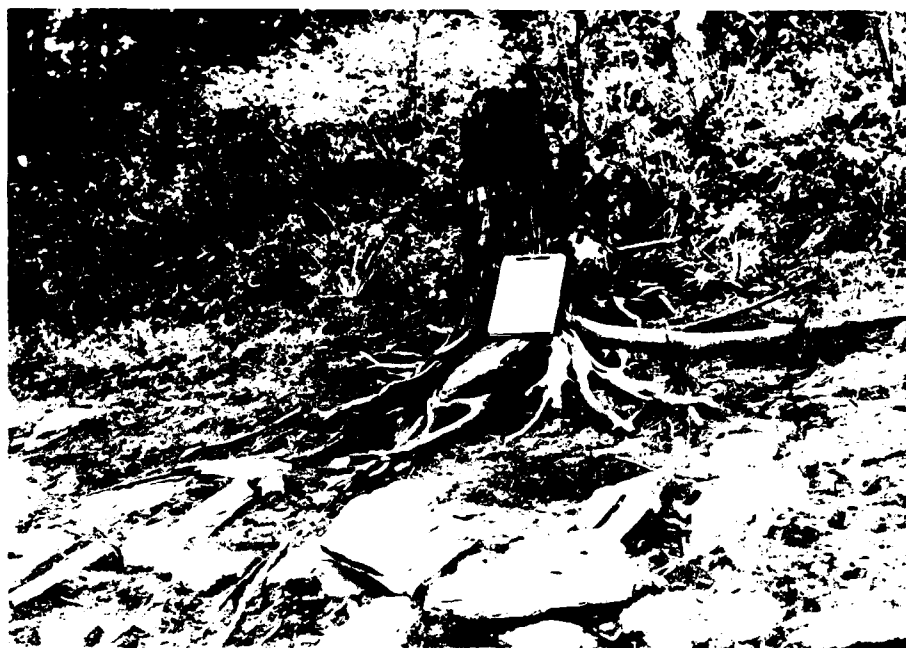
PHOTO NO. 7 - Rotted tree stump on upstream face of dam.

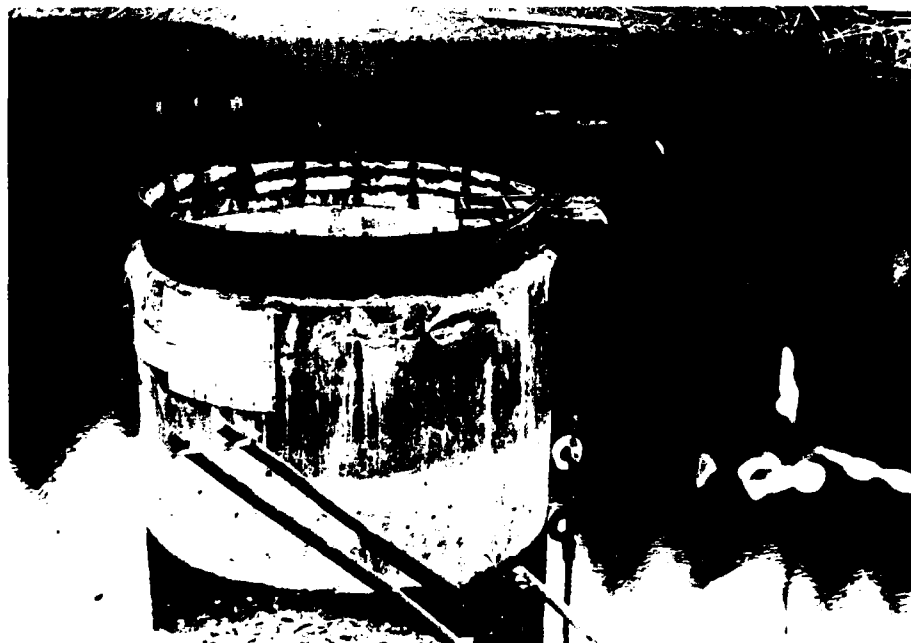
The circular spillway structure, as seen in Photo Nos. 8, 9 & 10, consists of three elements: a circular inlet overflow control, a vertical transition (cylindrical structure) and outlet tunnel. The circular spillway structure has provision for crest adjustment which was in place. The spillway structure is located at the toe of the embankment near the center of the dam. Visual inspection revealed that the concrete spillway structure has extensive decay on the top and the side surface. (Photo Nos. 9 & 10). The gate operating mechanism appeared to be operational, as the reservoir level was recently lowered. There was no means of access to the gate operating mechanism. There were remains of supports for a catwalk from the dam to the gate wheel as seen in Photo No. 11. The outlet gate, as seen in Photo No. 13, was subject to some minor leakage but otherwise appeared to be in fair condition.

PHOTO NO. 8 - Spillway crest and upper portion of riser.

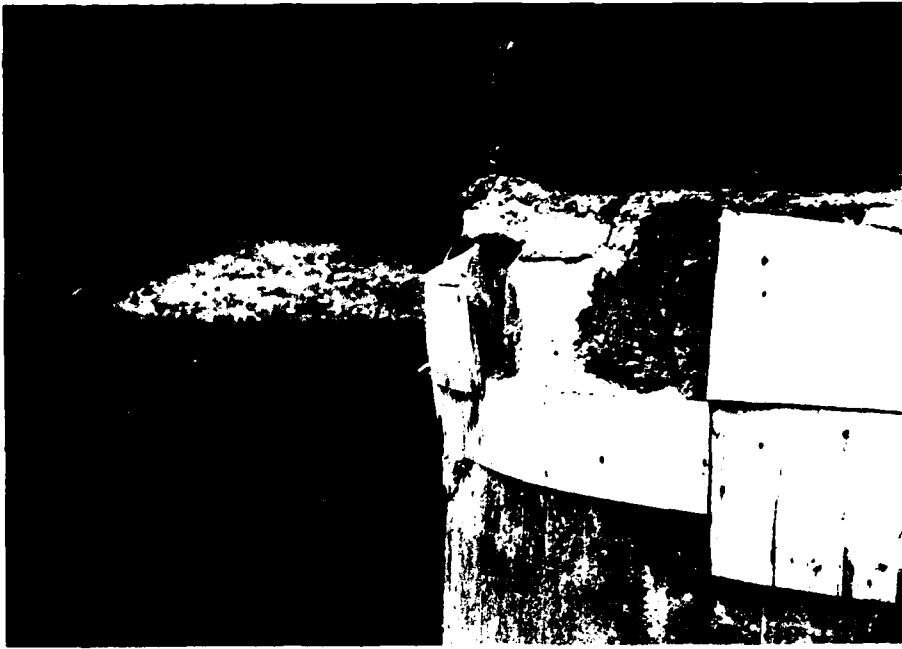
PHOTO NO. 9 - Detail of concrete spillway. Note plywood patch forms.
